Total Land Subsidence in the Gila Bend Area, Maricopa County  
Based on Sentinel-1 Satellite Interferometric Synthetic Aperture Radar (InSAR) Data  
Time Period of Analysis: 1.0 Years 02/12/2019 To 02/07/2020

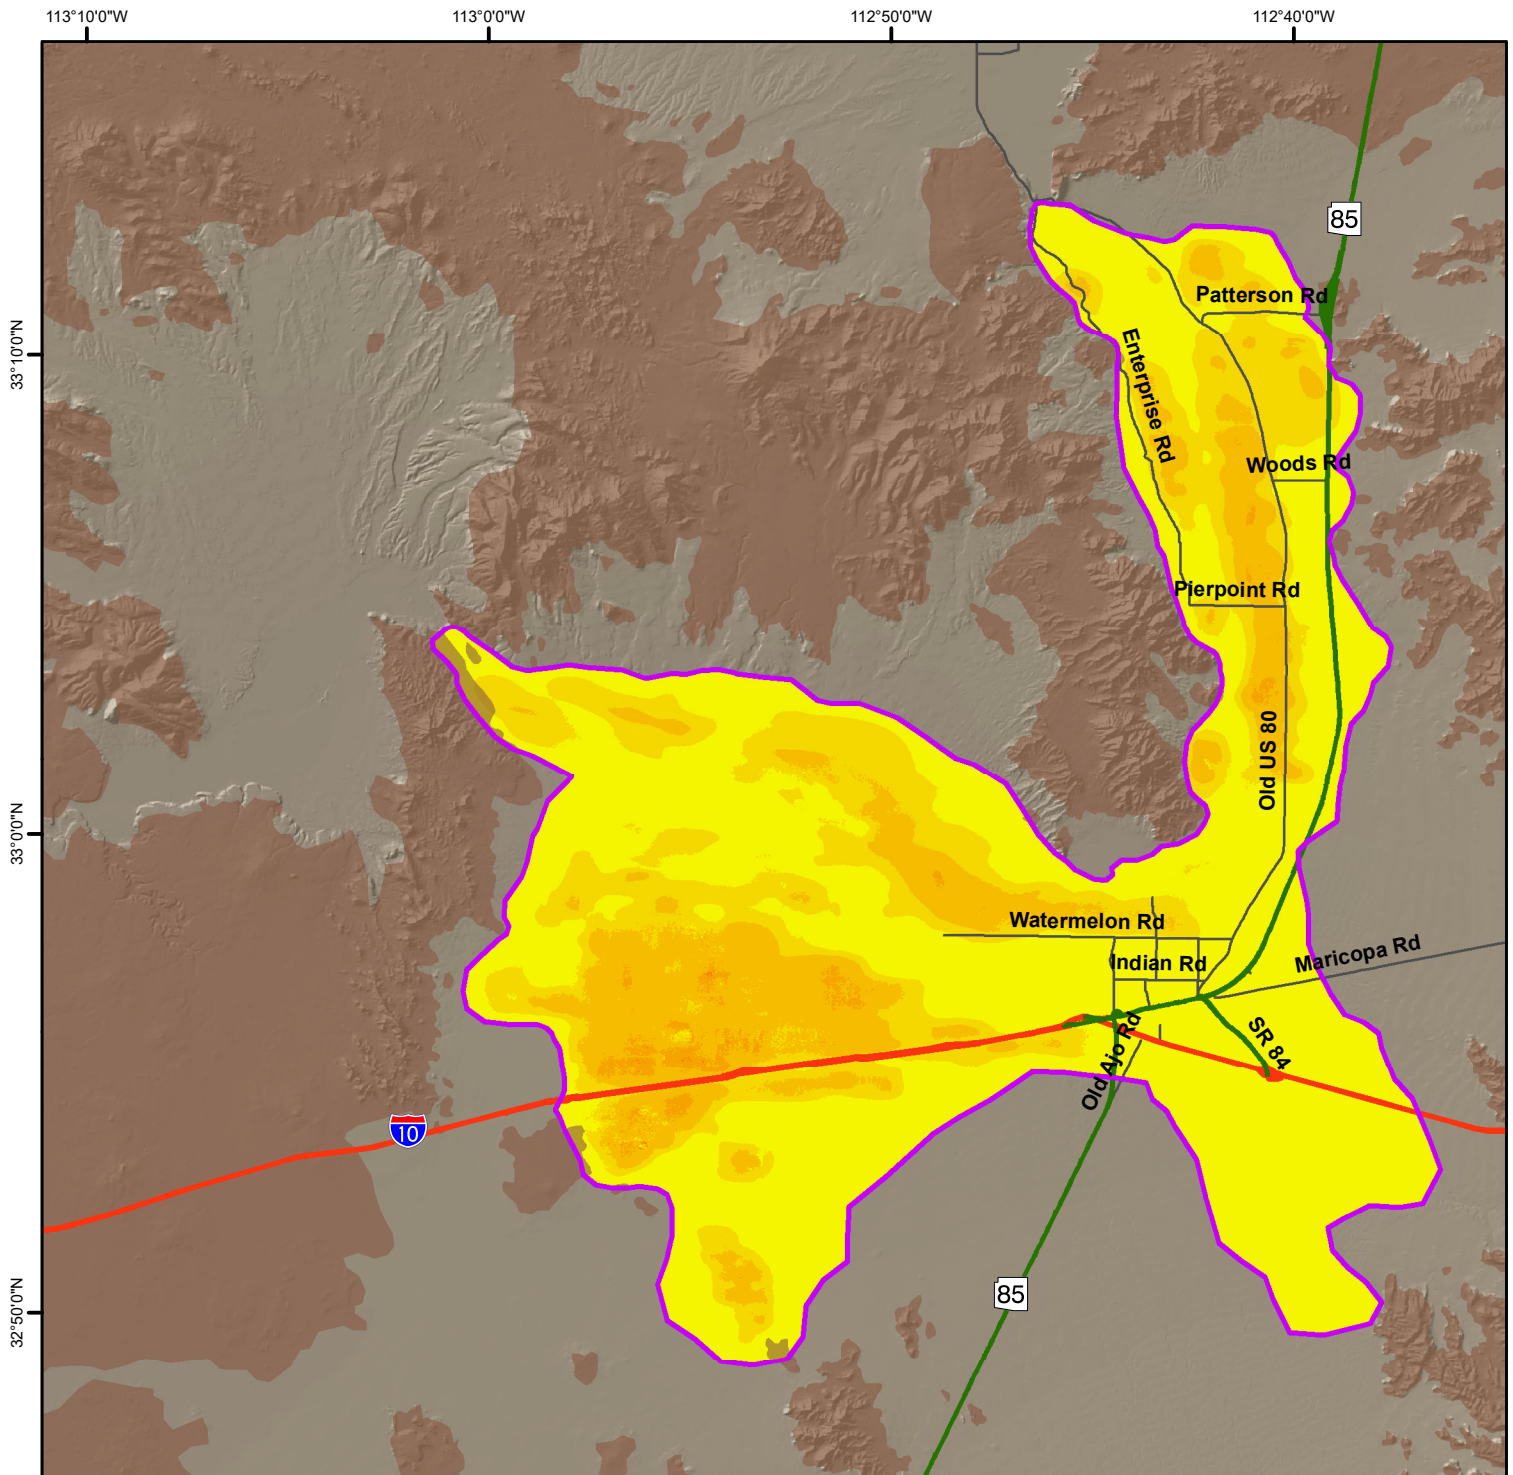
Decorrelation (white areas) are areas where the phase of the received satellite signal changed between satellite passes, causing the data to be unusable. This occurs in areas where the land surface has been disturbed (i.e. bodies of water, snow, agriculture areas, areas of development, etc).
